# Manhole Inspection Summary

Manhole # S25QQ1027MH

**Location** Address: **CLUB RD**

Cross Street: **GOODWOOD GARDEN**

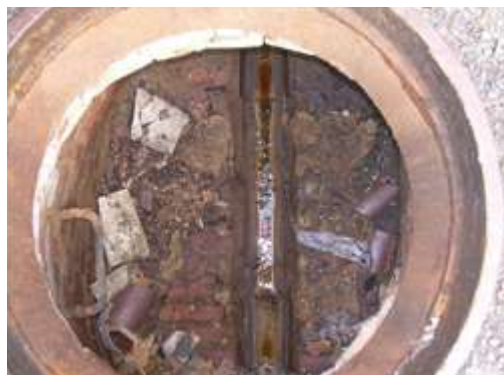
Top View

Evidence of surcharge - Bench debris.

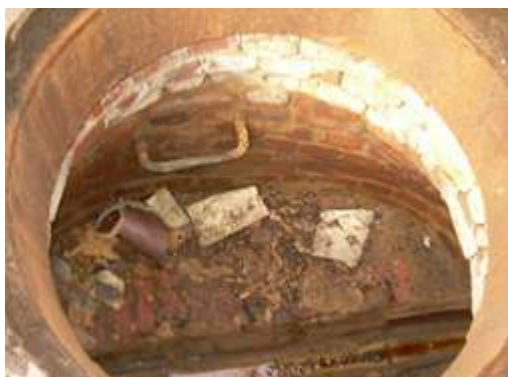
Defect

Frame leaks. Adjustment deterioration and infiltration. Corbel and Barrel deterioration and infiltration - other side.

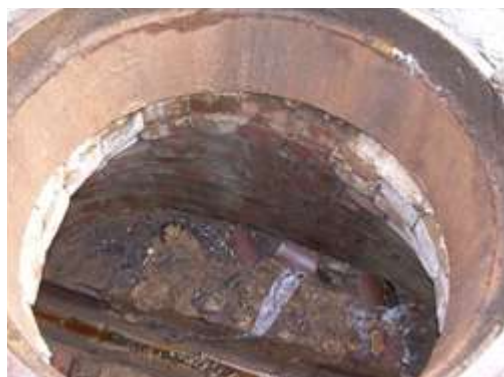
Defect

Frame leaks. Adjustment deterioration and infiltration. Corbel and Barrel deterioration and infiltration.

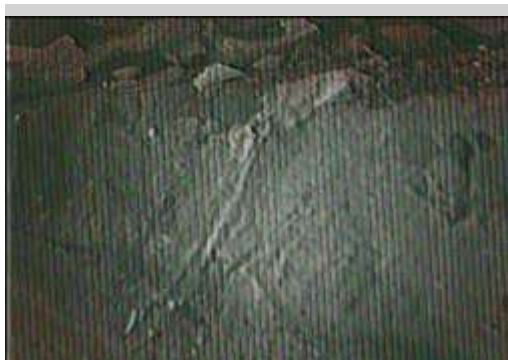
Defect

Channel cracked

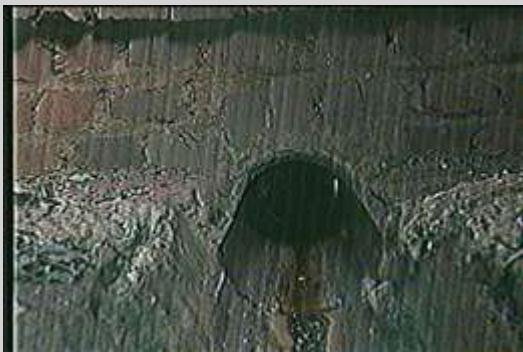
### 6 in. Circular Gravity Sewer Pipe Out @ 12 O'Clock

Infiltration: **Evidence** Pipe Seal Cond: **Cracked**

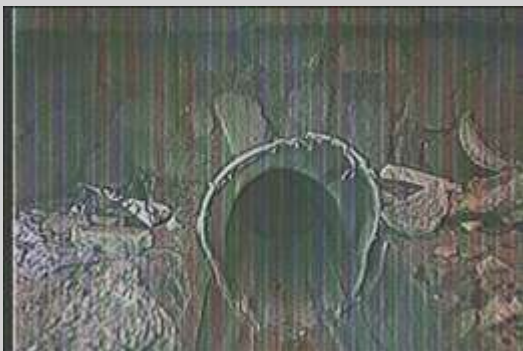
### 6 in. Circular Gravity Sewer Pipe In @ 6 O'Clock

Barrel and Channel deterioration.
